Manhole Inspection Summary

Manhole # S25GG_038MH

Insp Date: **9/10/07 10:16 AM**

Location Address: **1823 PENNSYLVANIA AVE**

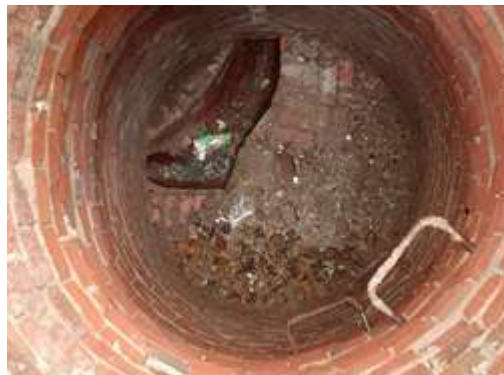
Top View

Barrel infiltration. Corroded steps. Bench and Channel debris.

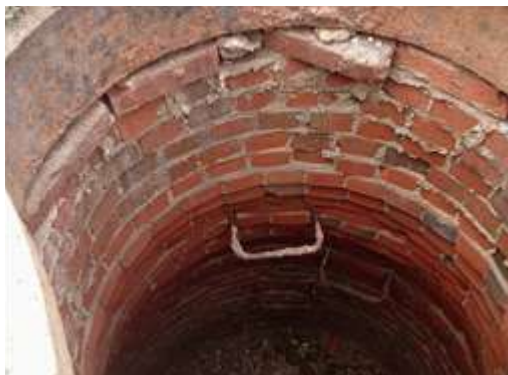
Defect

Frame leaks. Adjustment deterioration, loose brick and infiltration - other side.

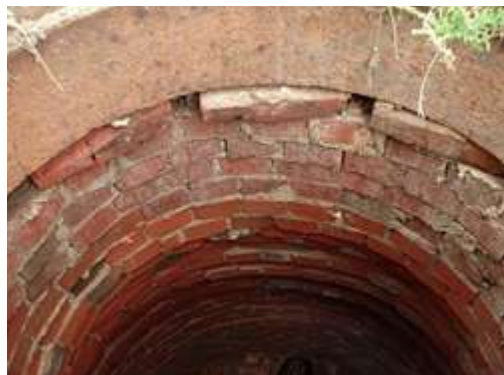
Defect

Frame leaks. Adjustment deterioration, loose brick and infiltration.

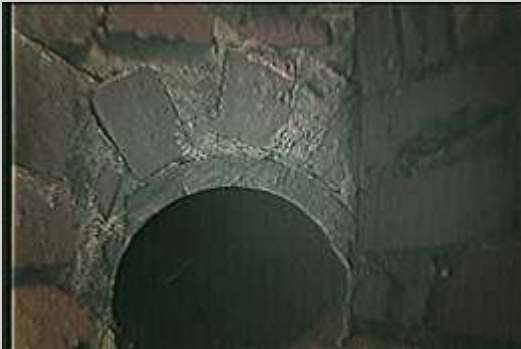
8 in. Circular Gravity Sewer Pipe Out @ 12 O'Clock

Infiltration: **None** Pipe Seal Cond: **Unknown**

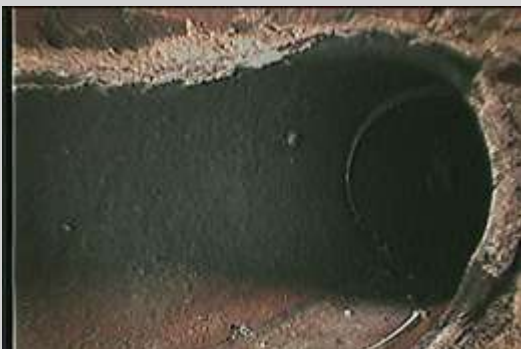
8 in. Circular Gravity Sewer Pipe In @ 9 O'Clock

Infiltration: **None** Pipe Seal Cond: **Cracked**
